Evaluation of MEMS-based In-place Inclinometers in Cold Regions

Margaret M. Darrow, Ph.D.
David. D. Jensen, E.I.T.

December 2012

INE/AUTC 12.38

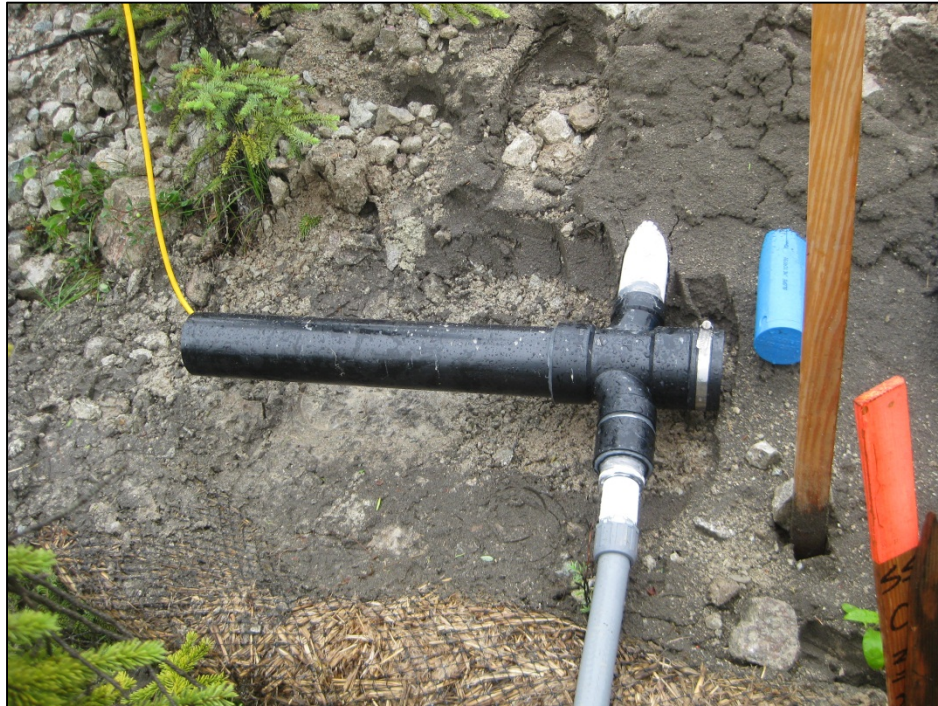
Figure C-9. PVC casing to flexible conduit adapter for the temperature measurement cables.
(Photograph by M. Darrow, July 2012)

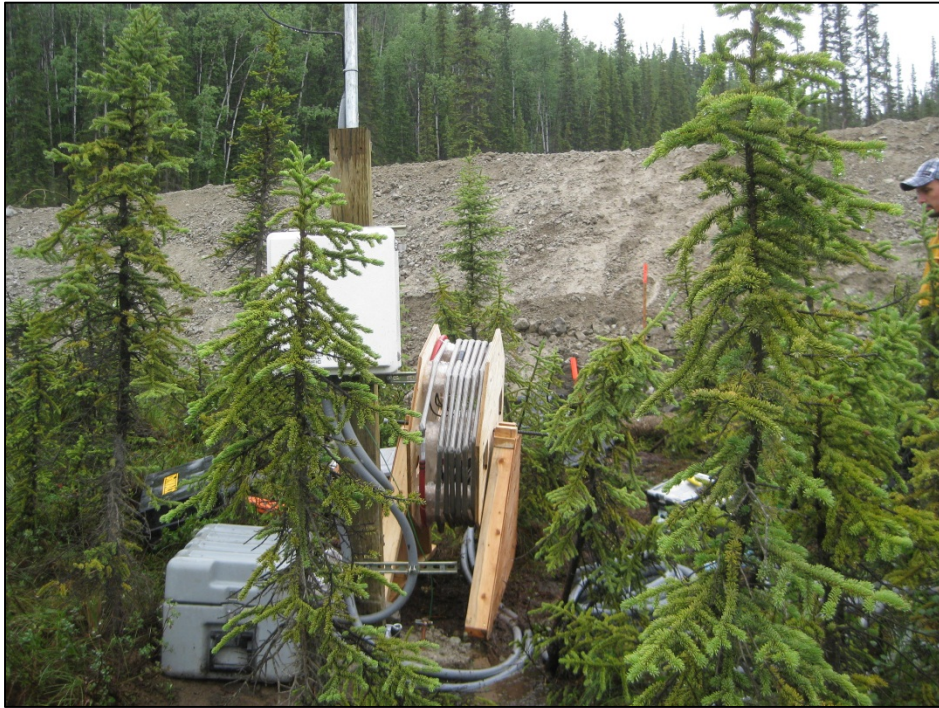
Figure C-11. Installation of SAA device, showing shipping reel position relative to embankment and ADAS. (Photograph by M. Darrow, July 2012)

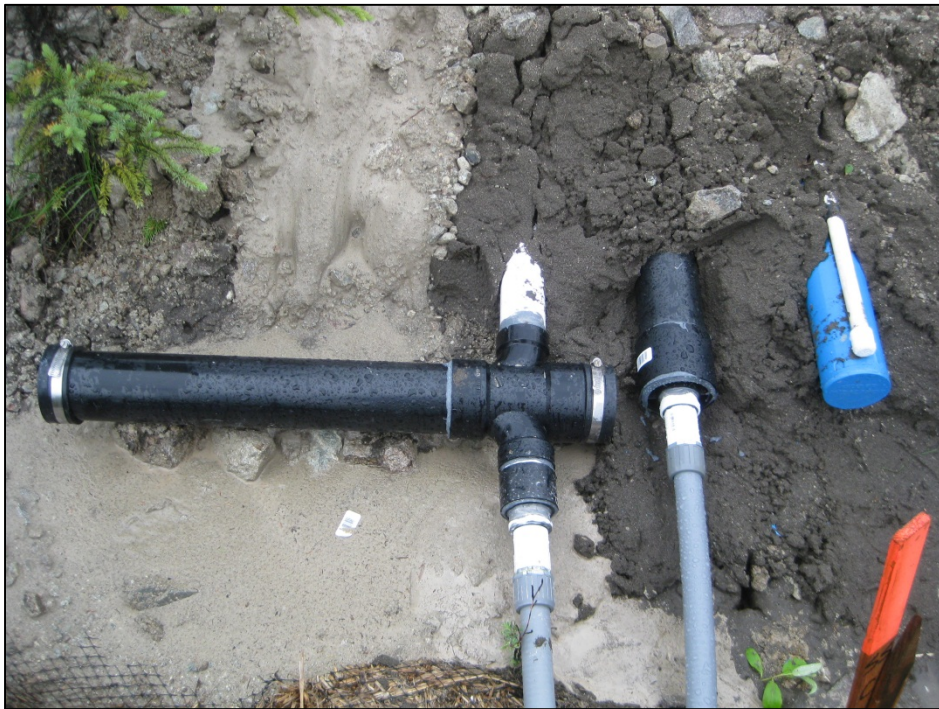
Figure C-12. PVC casing to flexible conduit adapter for SAA installation. (Photograph by M. Darrow, July 2012)

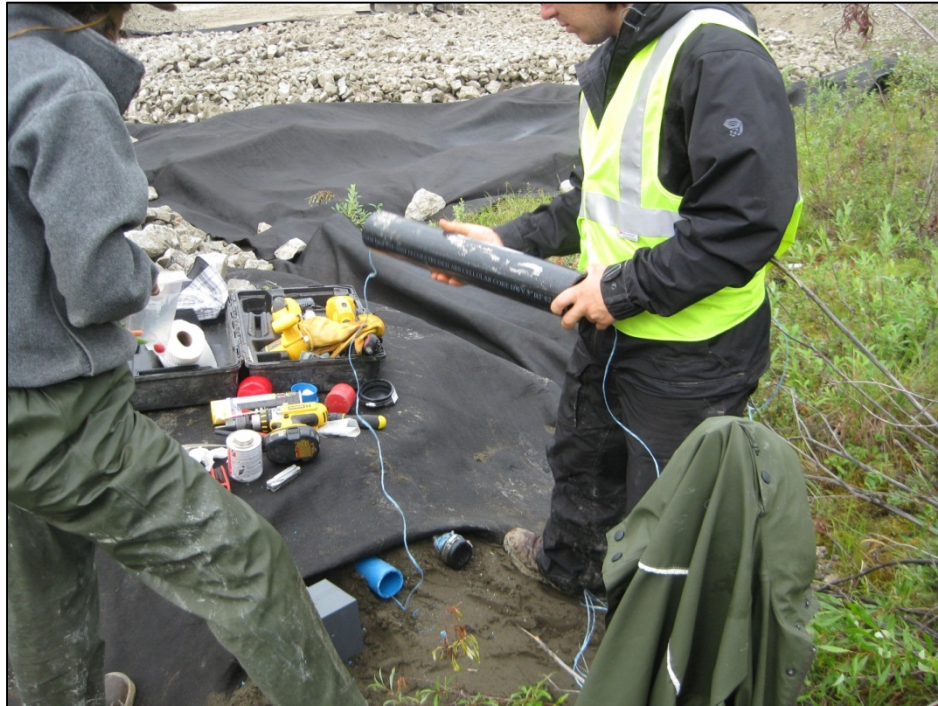
Figure C-14. Routing pull rope for SAA through ABS end cap adapter. (Photograph courtesy of J. Zottola, July 2012)

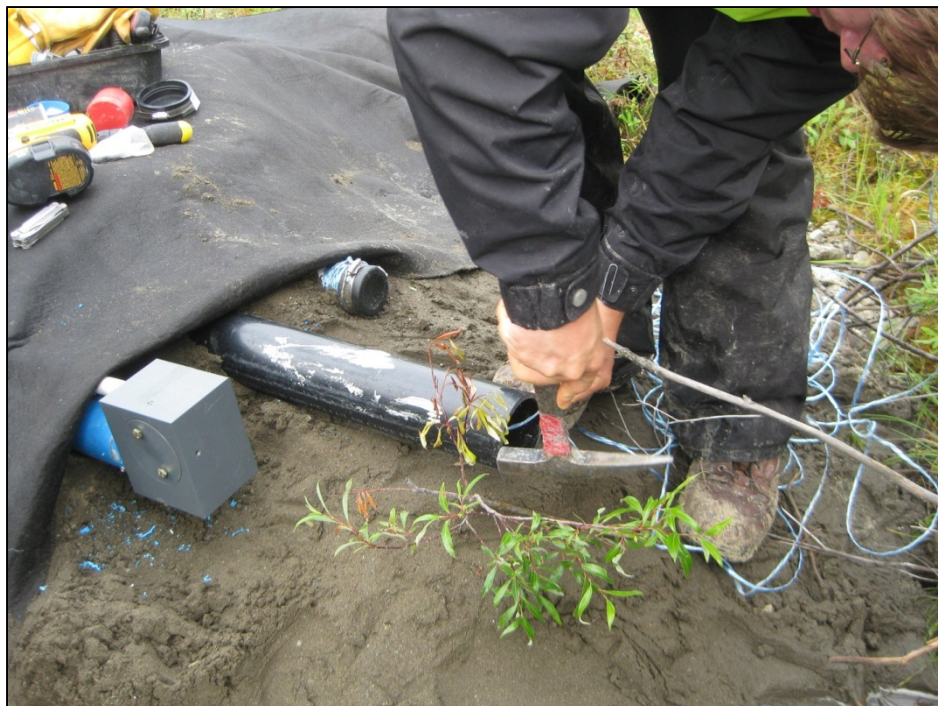
Figure C-15. Tapping ABS end cap adapter into the sand bedding to be flush with inner casing. (Photograph courtesy of J. Zottola, July 2012)

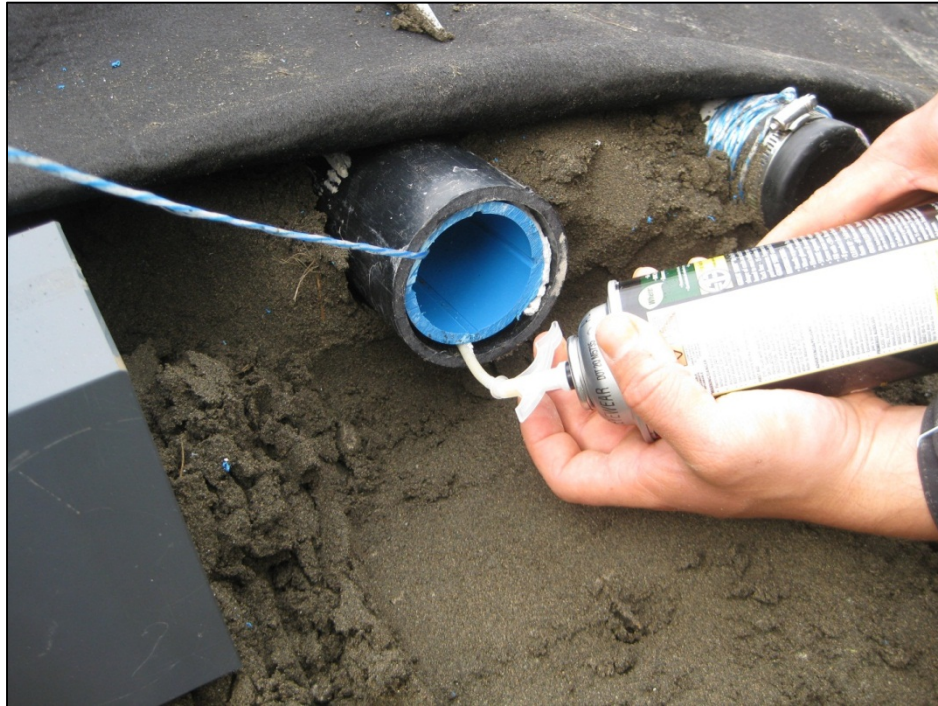
Figure C-16. Filling annulus space with expanding foam to seal outer ABS end cap adapter in place. (Photograph courtesy of J. Zottola, July 2012)

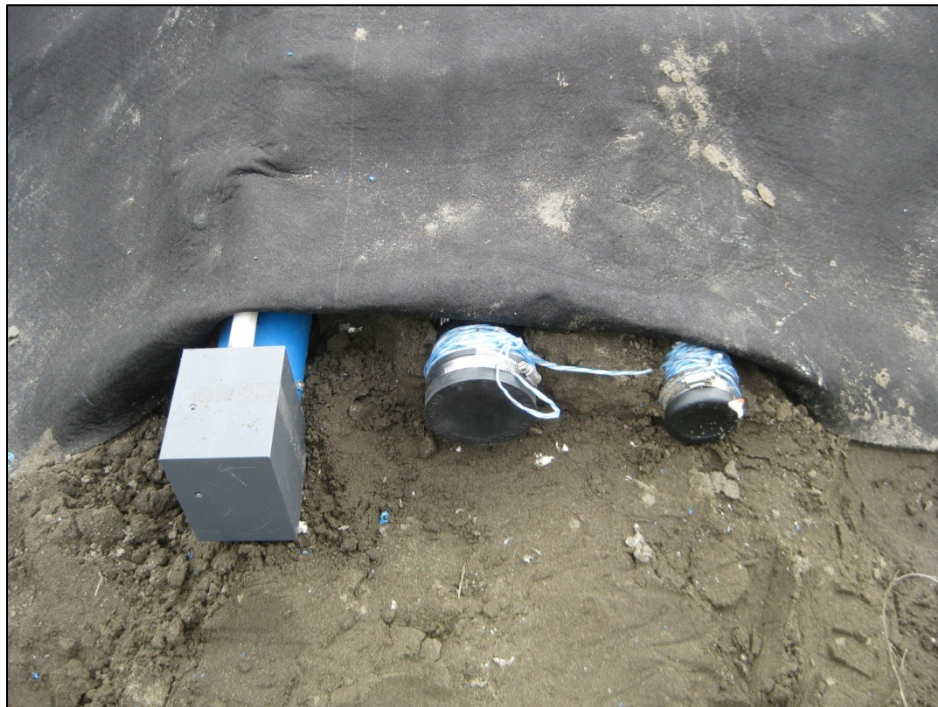
Figure C-17. Upslope casing ends secured. From left to right, dead-end pulley on guide casing for manual inclinometer probe measurements, sealed guide casing with tied-off SAA pull rope, sealed 2-in. PVC casing with tied-off TAC/thermistor string pull rope. (Photograph by M. Darrow, July 2012)

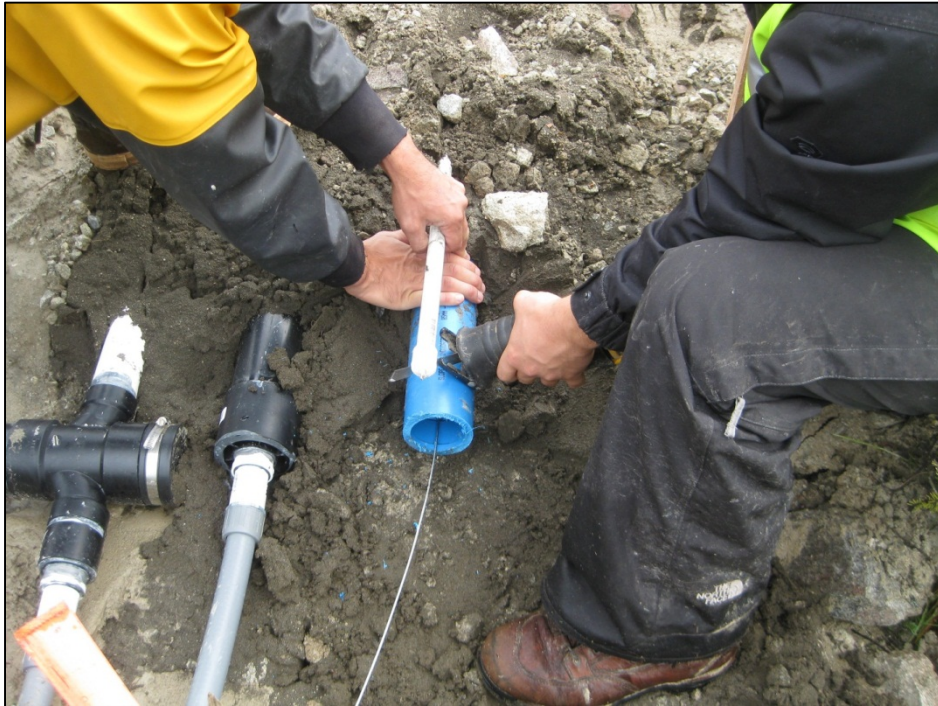
Figure C-18. Trimming the downslope guide casing for ABS end cap adapter. (Photograph by M. Darrow, July 2012)

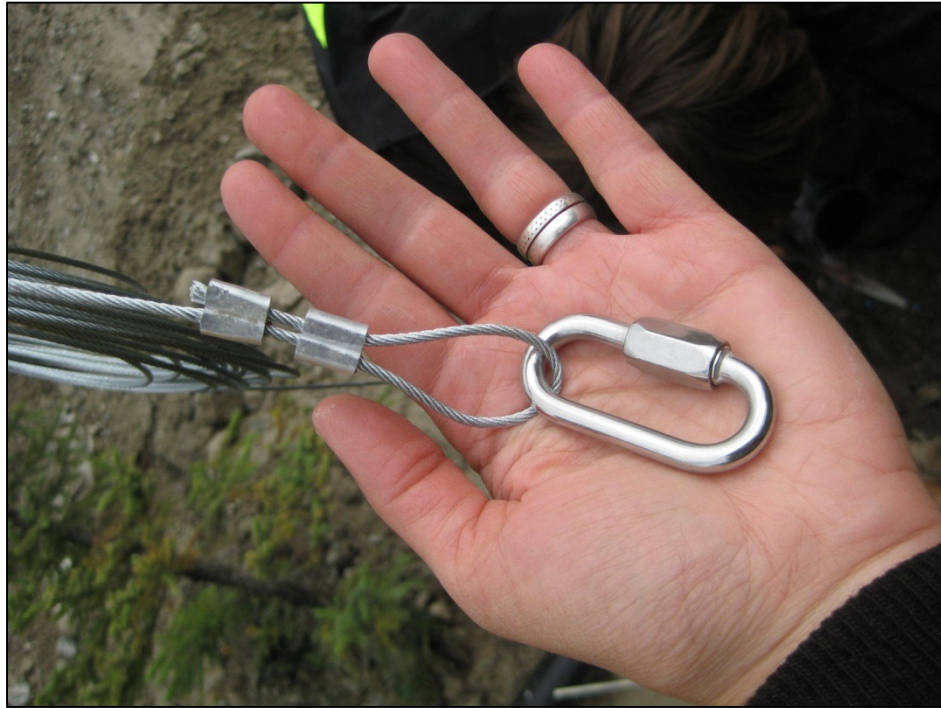
Figure C-20. Attaching 2 1/4-in. locking link to wire rope within guide casing. (Photograph by M. Darrow, July 2012)

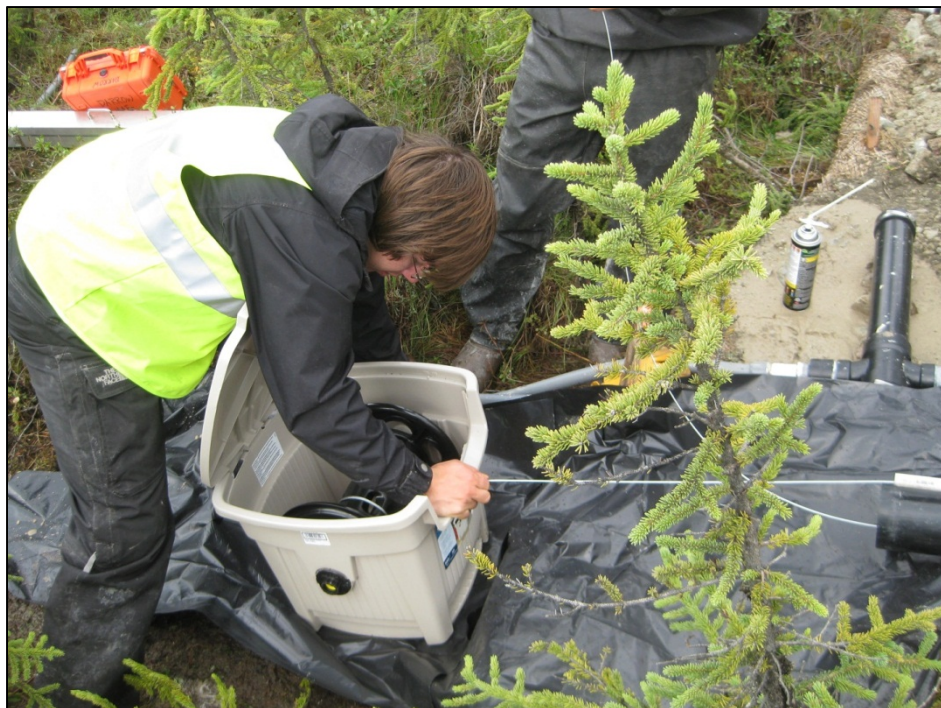
Figure C-21. Winding up excess wire rope from within casing assembly. (Photograph by M. Darrow, July 2012)

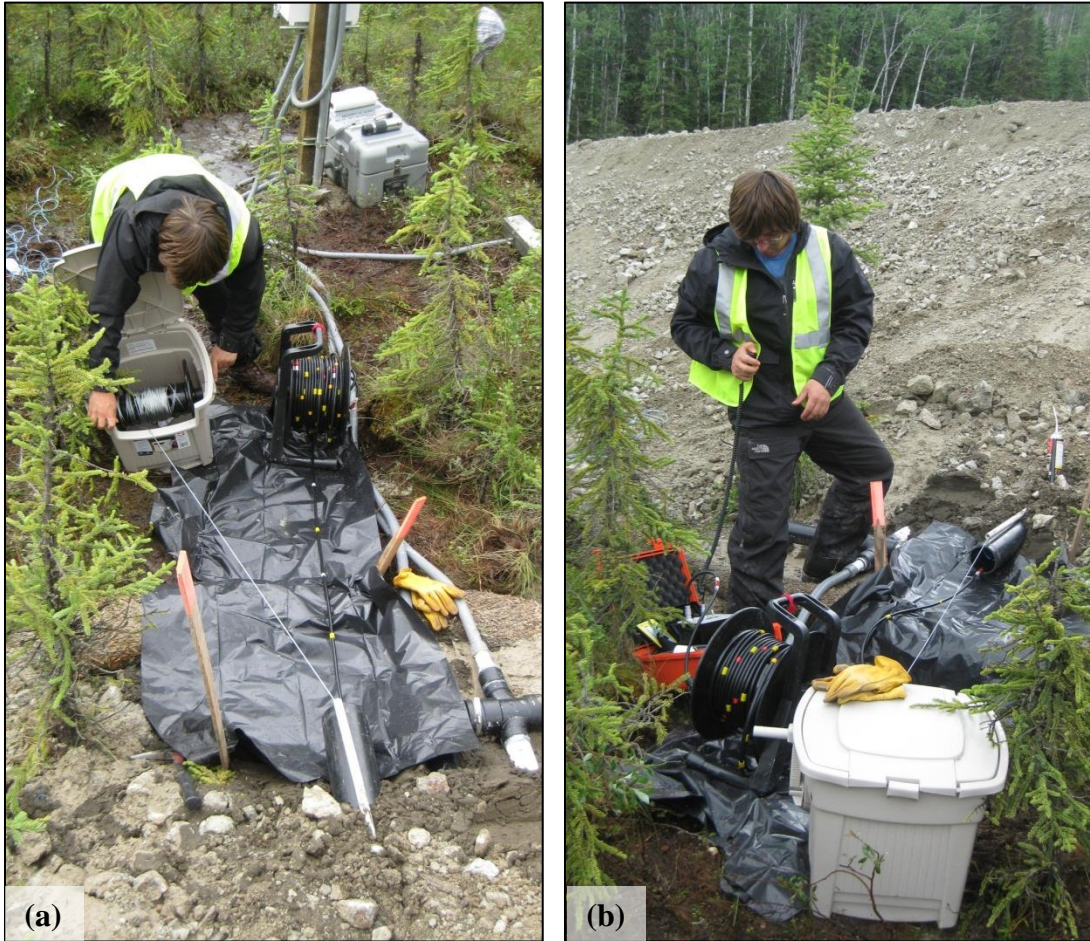
Figure C-22. Taking manual inclinometer probe measurements. (a) Feeding inclinometer probe cable into casing by reeling up the wire rope; (c) taking readings as the cable is retracted from the casing. (Photographs by M. Darrow, July 2012)

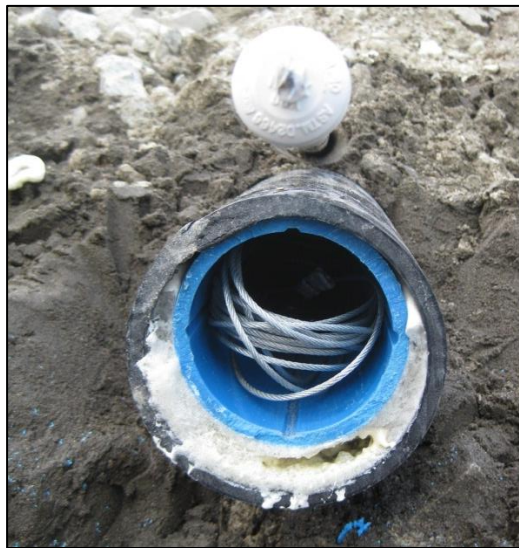
Figure C-23. Downslope guide casing termination. Wire rope is tucked into casing for easy retrieval for next reading. (Photographs by M. Darrow, July 2012)

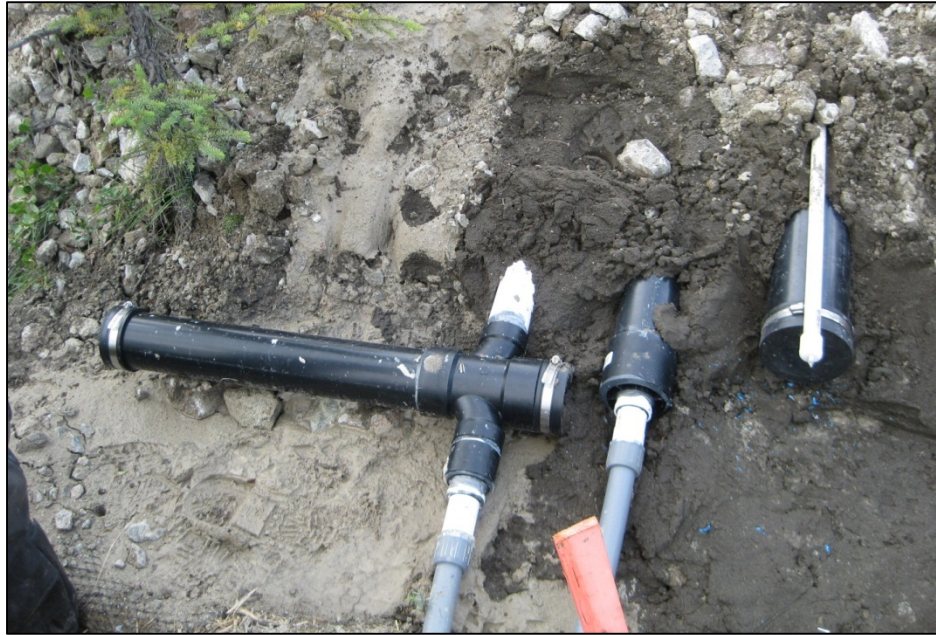
Figure C-24. Downslope casing ends secured. From left to right, ABS casing to flexible conduit adapters for TAC/thermistor cables and SAA device, and sealed guide casing for manual inclinometer probe measurements. (Photograph by M. Darrow, July 2012)

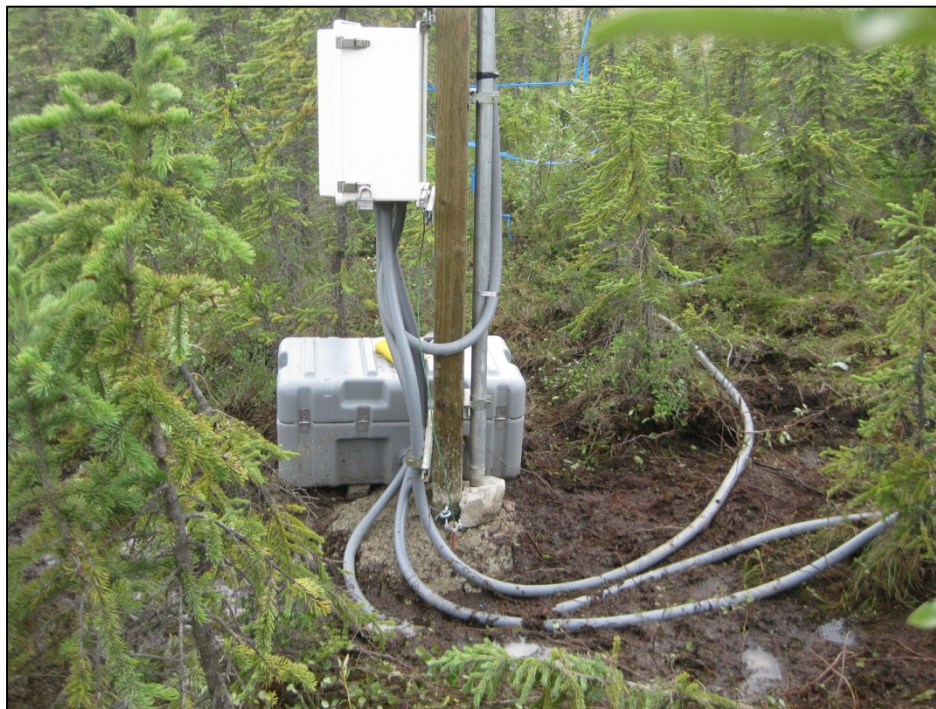
Figure C-25. Battery box and enclosure for ADAS. (Photograph by M. Darrow, July 2012)

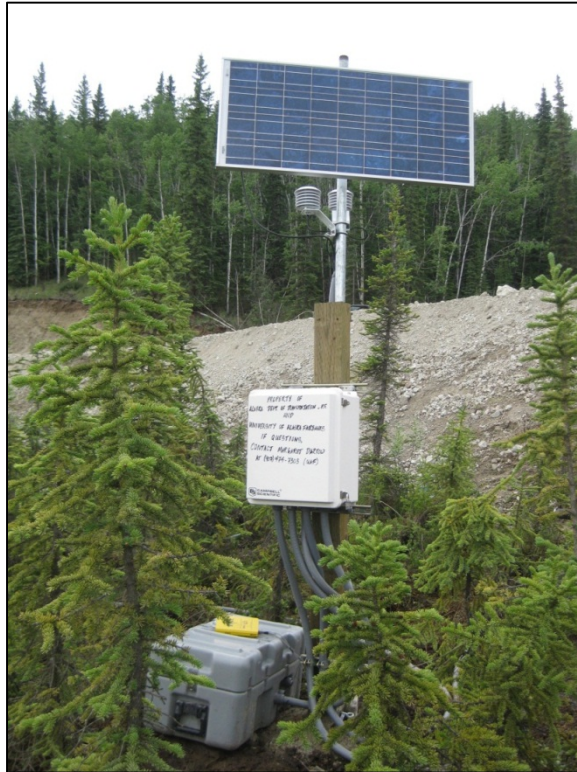
Figure C-26. Final ADAS configuration located near the downslope toe of the embankment. The thermal berm is visible behind the ADAS. (Photograph by M. Darrow, July 2012)

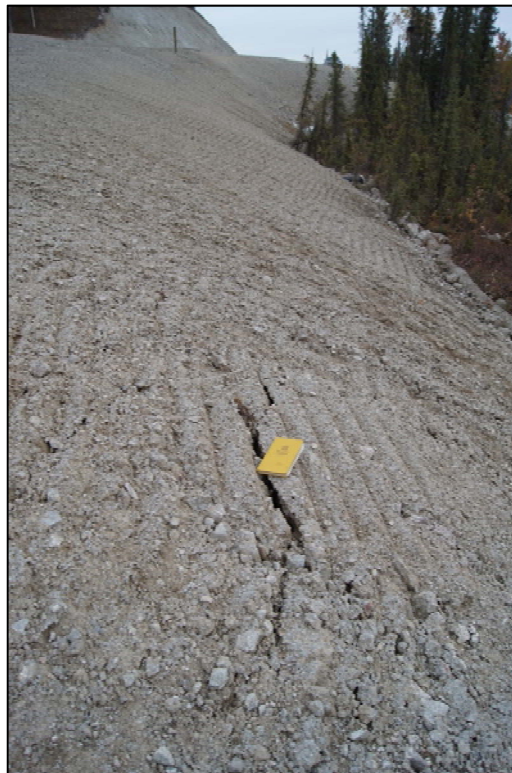
Figure C-27. Cracks in the thermal berm on September 14, 2012. (Photograph by D. Jensen)

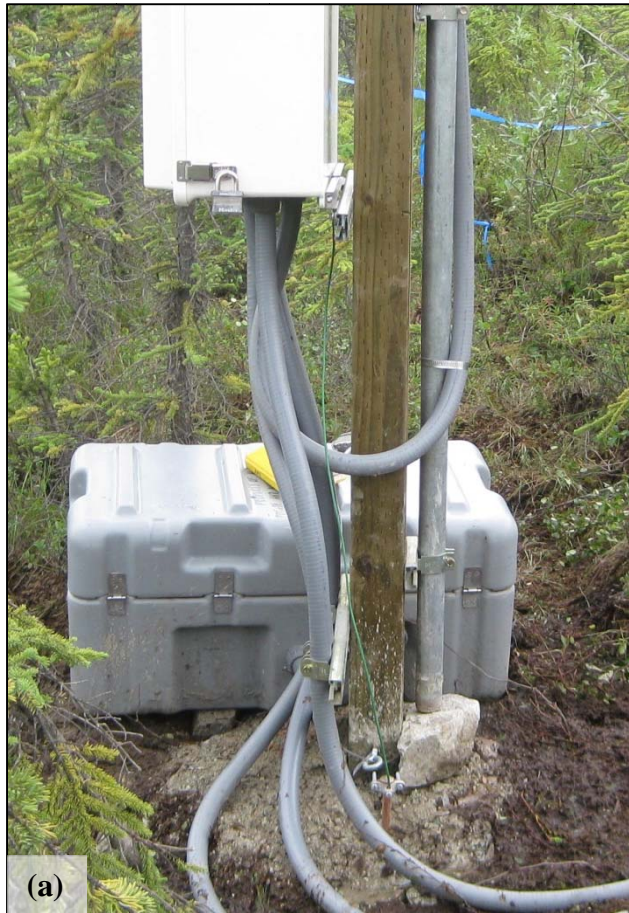
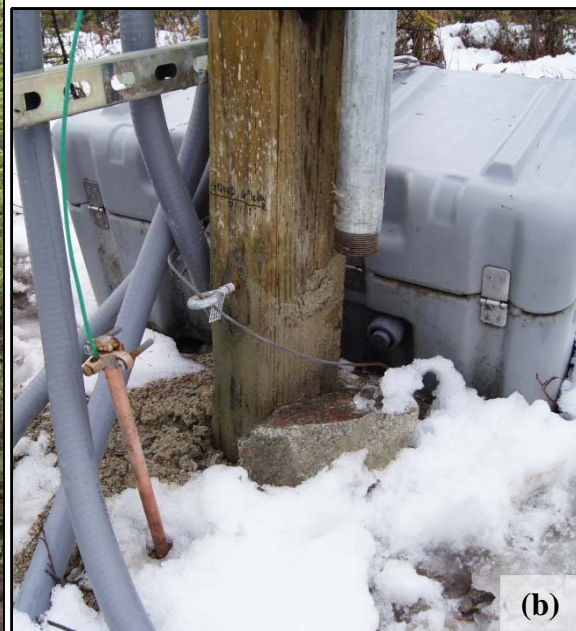
Figure C-28. Changes at the ADAS during the fall of 2012. (a) Post, solar panel support, and grounding rod on July 11, 2012; (b) Settlement of ground surface as of October 6, 2012. (Photographs by M. Darrow and D. Jensen)

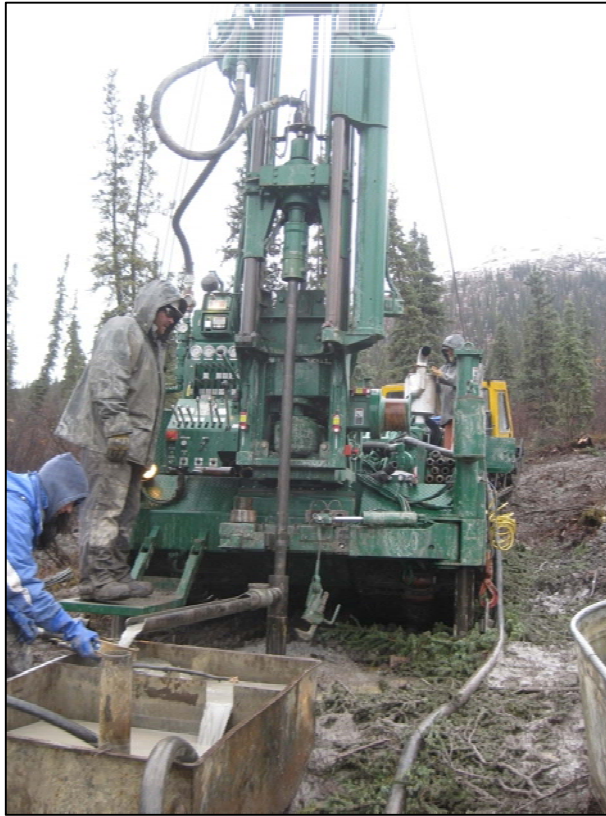
Figure D-1. Drilling TH12-9004 with tricone and casing. (Photograph by M. Darrow, Sept. 2012)

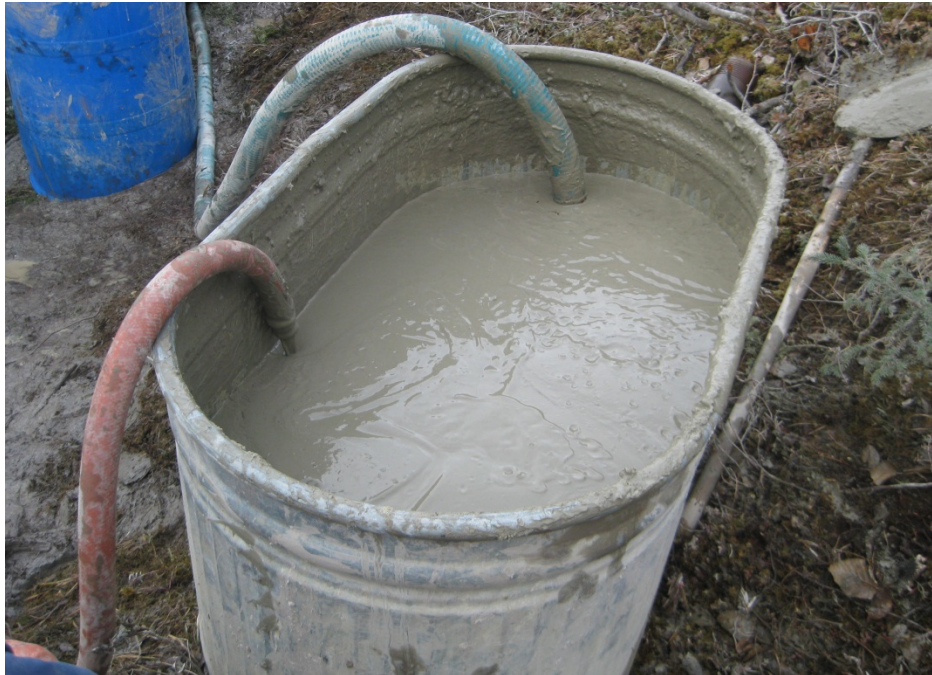
Figure D-2. Cement-bentonite grout during the back-filling process. (Photograph by M. Darrow, Sept 2012)

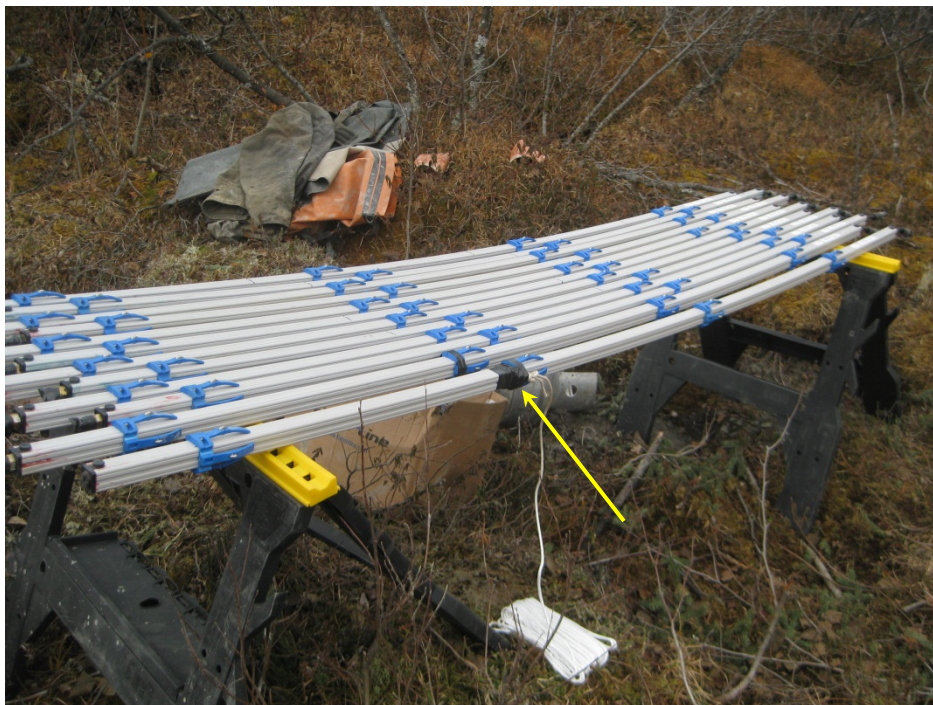
Figure D-3. INC500 modules, staged and ready for installation. A safety line was attached to the lowest module (indicated by the yellow arrow). (Photograph by M. Darrow, Sept. 2012)

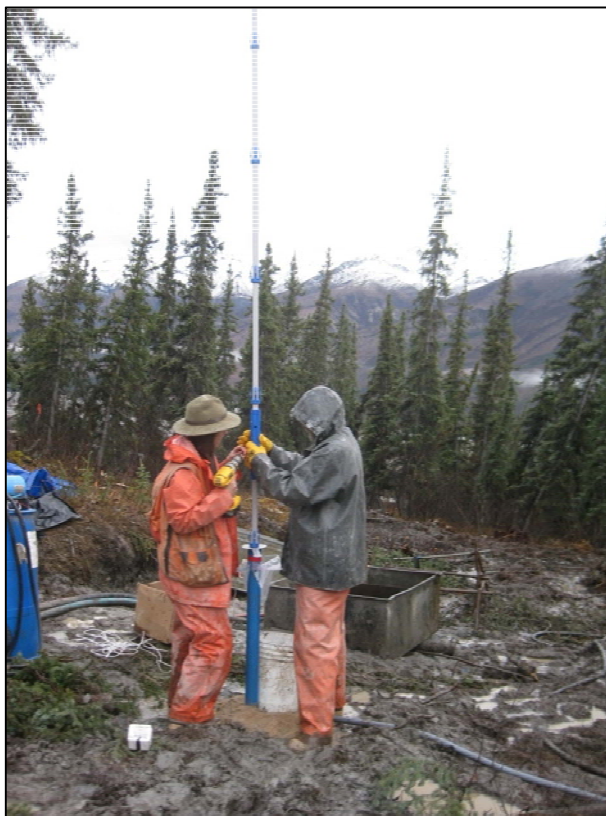
Figure D-4. Installing the INC500 within the guide casing in TH12-9004. (Photograph by J. Simpson, Sept. 2012)

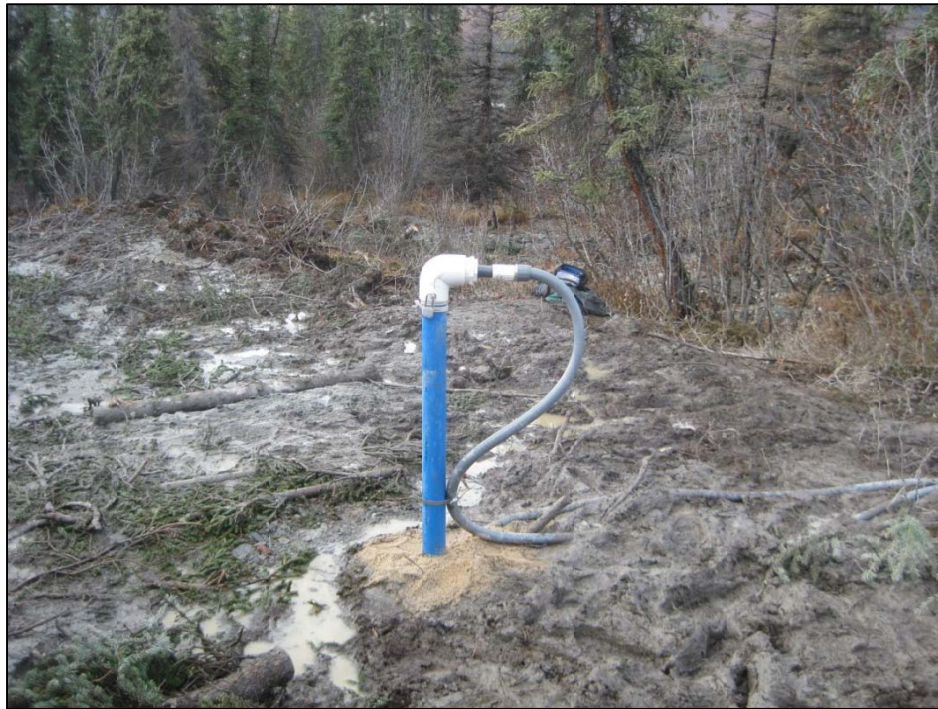
Figure D-6. Completed casing and instrument installation in TH12-9004. (Photograph by M. Darrow, Sept. 2012)

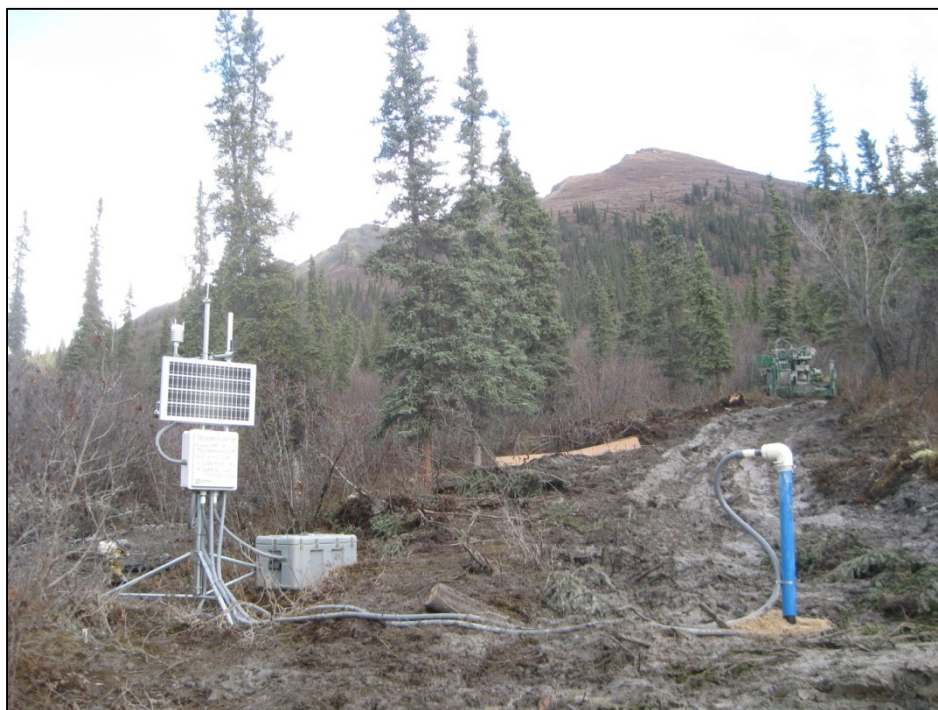
Figure D-7. Completed ADAS location and casing installation of TH12-9004. (Photograph by M. Darrow, Sept. 2012)
